Manhole Inspection Summary

Manhole # S47W1_023MH

Location Address: **1301 Chesapeake Ave**

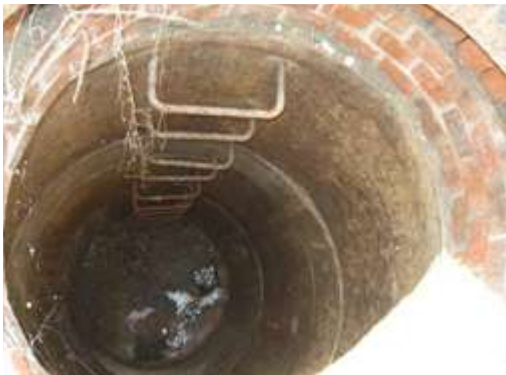
Steps Count: **12** Missing: **0** ☐ Corroded

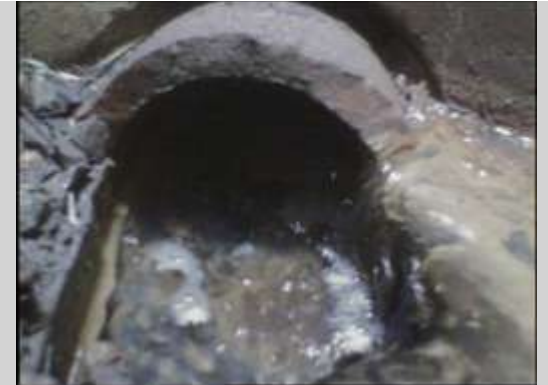
12 O'Clock Outflow

8 in. Circular Gravity Sewer
Pipe Out @ 12 O'Clock

Pipe Height: **9.6** (in.) Rod and Bar (Angled)
Pipe Material: **Unknown** ☐ Pipe Lined
Invert Depth: **14.45** (ft.) Flow Characteristics: **Slow**
Deposits: ☒ None ☐ **Mud** ☐ Sludge ☐ Debris ☐ Grease
Silt Depth: (in.) Deposits Extent:
Infiltration: **Evidence** Pipe Seal Cond: **Cracked**

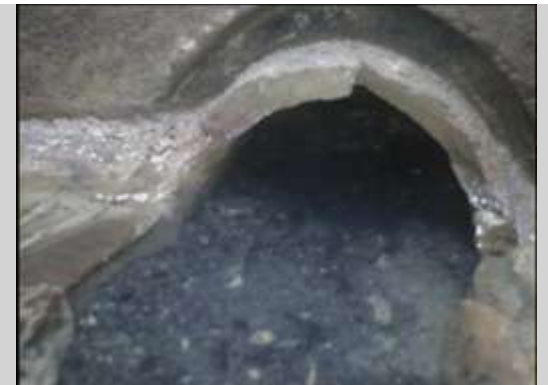
3 O'Clock Inflow

8 in. Circular Gravity Sewer
Pipe In @ 3 O'Clock

Pipe Height: **10.8** (in.) Rod and Bar (Angled)
Pipe Material: **Unknown** ☐ Pipe Lined
Invert Depth: **14.40** (ft.) Flow Characteristics: **Slow**
Deposits: ☐ None ☒ **Mud** ☐ Sludge ☐ Debris ☐ Grease
Silt Depth: **6** (in.) Deposits Extent: **Medium**
Infiltration: **Evidence** Pipe Seal Cond: **Cracked**
